# **Restoration of 1880-1890 Franz Schwarzer Zither**

**Performed by Ron Cook**

**May, 2005**

**For D. Joseph Madl of Billings, Montana**

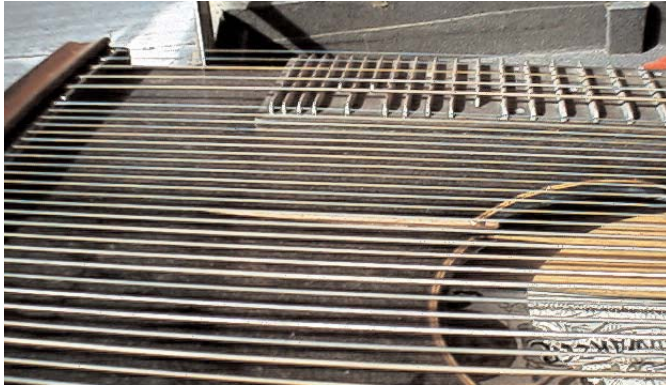
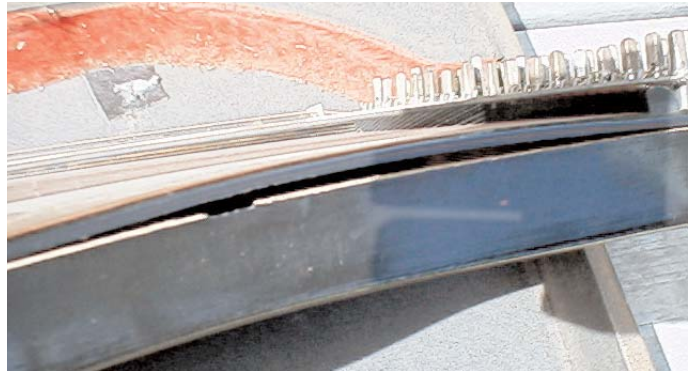
On Day 1, when the zither arrived, I could see what we already knew: that it needed crack and glue joint repairs and a new “foot” for the bottom. As I took a little closer look, I found out that because of the failed side glue joint, the string tension had slightly warped the body and soundboard, which probably caused the top to crack. I planned to remove strings and take a closer look the next day.

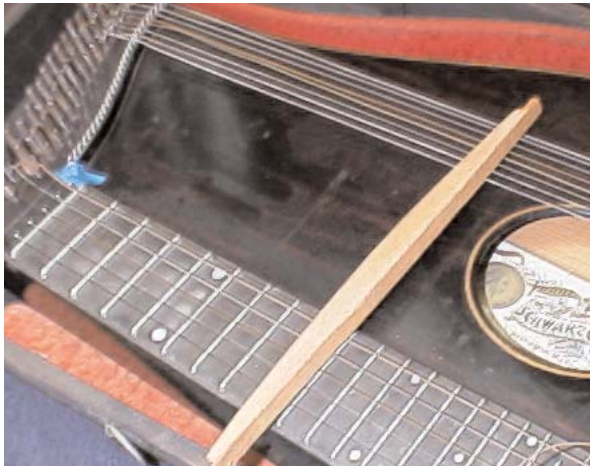
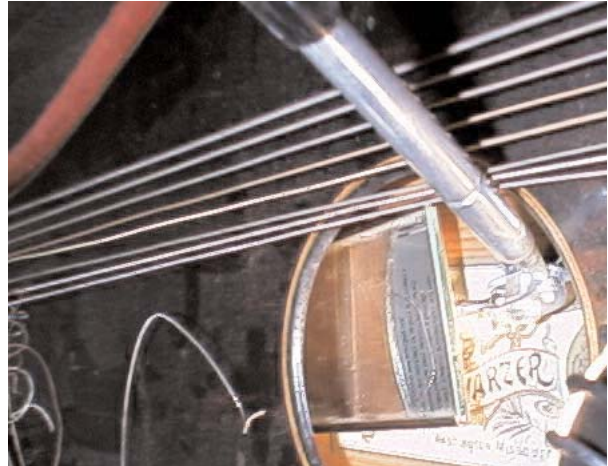
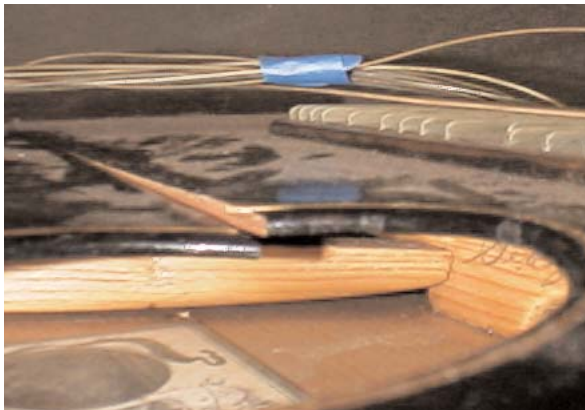
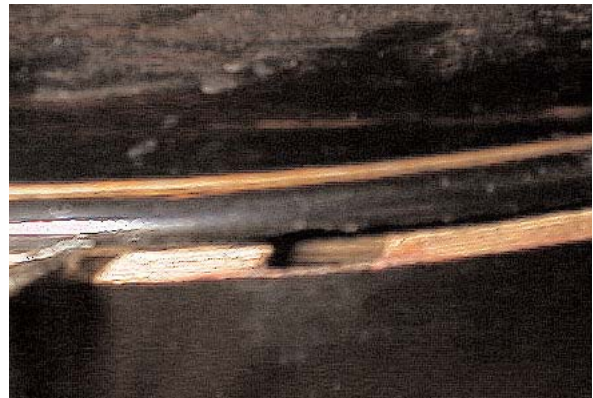
The next day, Day 2, I took the zither out to my workshop so I could remove most of the strings from their tuning pins and loosen those that weren't in the way of needed repairs. As I moved the zither around, I noticed the sound of something rattling inside the body cavity. I took my inspection mirror and light and looked around to find a few surprises.

First, the rattling sound came from a large brace that had separated completely from the top and was caught under a scalloped lengthwise brace. The top two pictures show the removed brace and the location under the soundboard (seen in mirror) where the brace came from. Second, the front brace, under the top crack (lower left photo), was partially separated. This separation was caused by the stress from a broken tenon that fit into a mortise slot in the fingerboard brace. The last picture shows one of the side mortise slots where a brace should rest. The large loose brace also had a broken tenon on one end (the end that fit into the side mortise slot), and a crack at the other tenon.

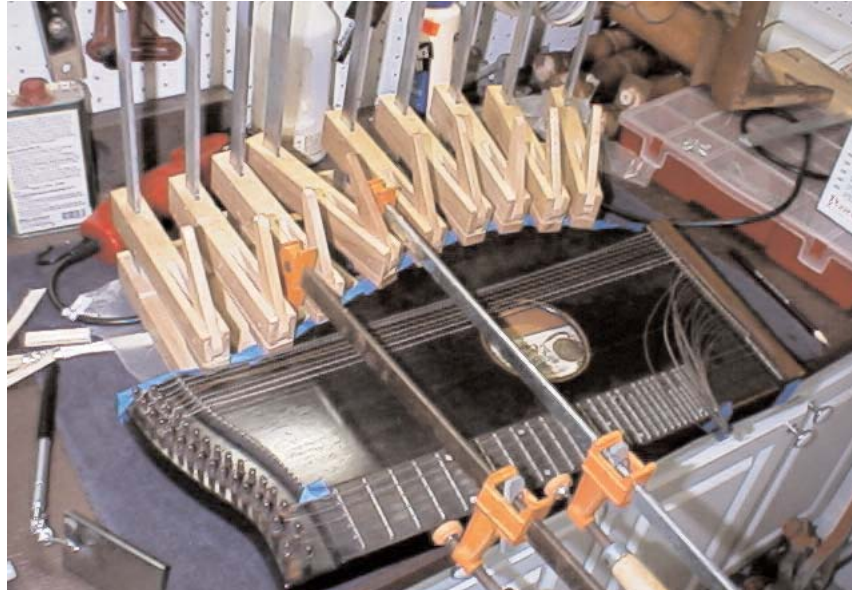
The next day, Day 4, when I removed the clamps from the previous day's gluing, I was disappointed to see that the brace and crack gluing failed. The brace slipped down, causing the crack to open up again. More head scratching.

The more I thought about it, the more I felt that the slight warp to the body was making it difficult to fix the brace under the crack and to close up the crack. I decided that repairing the side would stabilize the body enough so the two braces and the crack repairs would hold better.

I used a painter's tape to mask both sides of the side joint so glue wouldn't squeeze out and mess up the finish. I also scraped the joint edges with a tiny knife to remove the old hide glue. Using Titebond, I flooded the joint and applied cam clamps to pull the joint closed. The bar clamps are to pull the side in slightly to straighten up the body warp as much as possible.

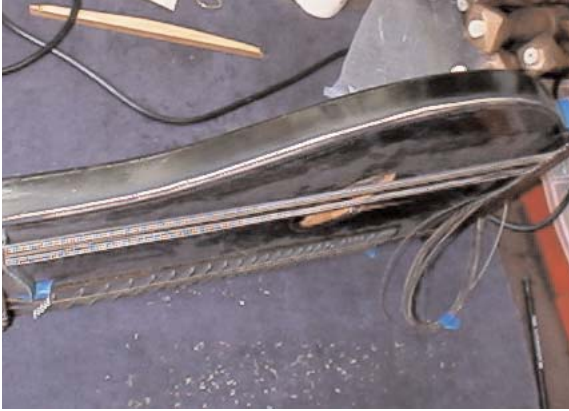
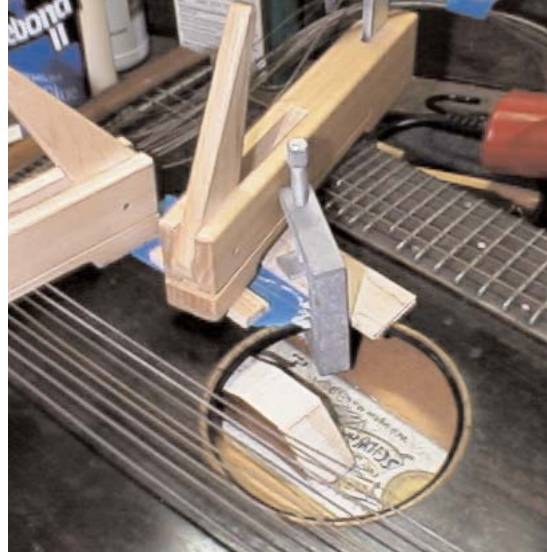
The side gluing was successful. A little scraping removed the beaded up glue squeeze-out, and a little sanding with 320 grit to 600 grit paper smoothed the edges. I would apply a matching finish to this edge later.

As I mentioned before, the braces had missing or broken tenons, so I had the idea of putting a small block under the end of the brace to keep it pushed up against the sound board. In the bottom of one of my workshop drawers I found some old aluminum clamps that were small enough to fit under the brace to pull it up, and after again scraping and applying glue to the brace under the crack I tightened the clamp, little by little, pushing a wooden wedge under the brace to even out the clamping stress. It took several minutes, but I was able to get good contact.

Once clamped, I inserted and glued the small block under the end of the brace next to the keyboard brace.

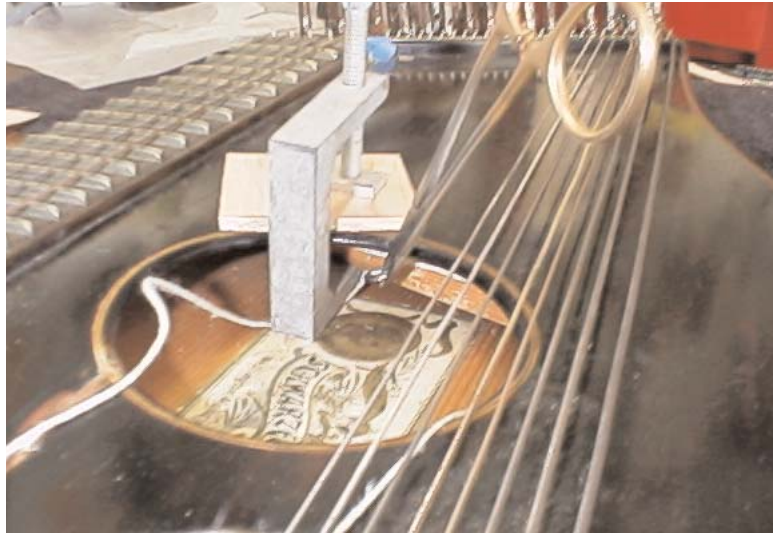
Because the tenon was missing on one side and broken on the other, and also because it would be impossible to create new tenons and insert them into the mortise slots (unless the top was totally removed), I decided to glue the brace in as close to its original position as possible. At least, with this brace, I was able to do a complete scraping of the old hide glue off of the top.

To start, I drilled a couple of small holes in the brace and ran a piece of string through it so I could maneuver it (and not lose it). My first attempts at installing the brace were very frustrating, to say the least. Every time I had it in place, it rolled and dropped down. When I did finally get it in place and clamped, it wouldn't clamp all the way up. I took my inspection mirror and found another side brace in the way by barely 1/8 inch. The glued-in brace was resting on it. I again removed the brace, and let my brain (and my back) rest for another day.

On Day 8, I was able to look at this part of the repair with fresh eyes. I put a small slot in the brace to go over the side brace and screwed in a small eye bolt that made it extremely easy to clamp to and maneuver the brace. Day 7 took several hours to get nowhere. Day 8, took 20 minutes to successfully glue, insert, and clamp the brace in place.

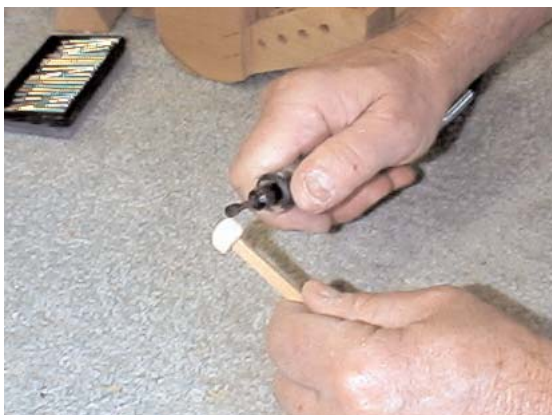
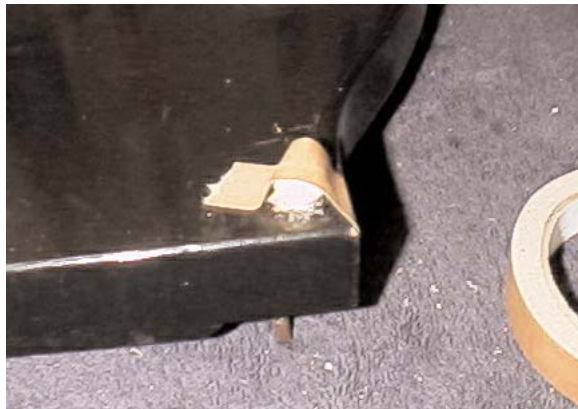
The two original ivory feet have tiny “spikes” on them. I’m not sure of the reason for this, especially since these would scratch table tops or poke a player’s legs when played on the lap, but I think there might have been rubber cushions on them at one time. Since rubber deteriorates and crumbles off over time, that might account for the exposed spikes.

Several years ago, I acquired several pieces of antique ivory, some fossilized, from a dealer at a downtown flea market. These had evidently been used by a jewelry maker, since many were cut into pendant shapes. I took one small piece, drilled it to fit the dowel the missing foot was once attached to, and carved it to about the size of the originals. A little sanding and some white glue was all it took to complete this portion of the repairs.

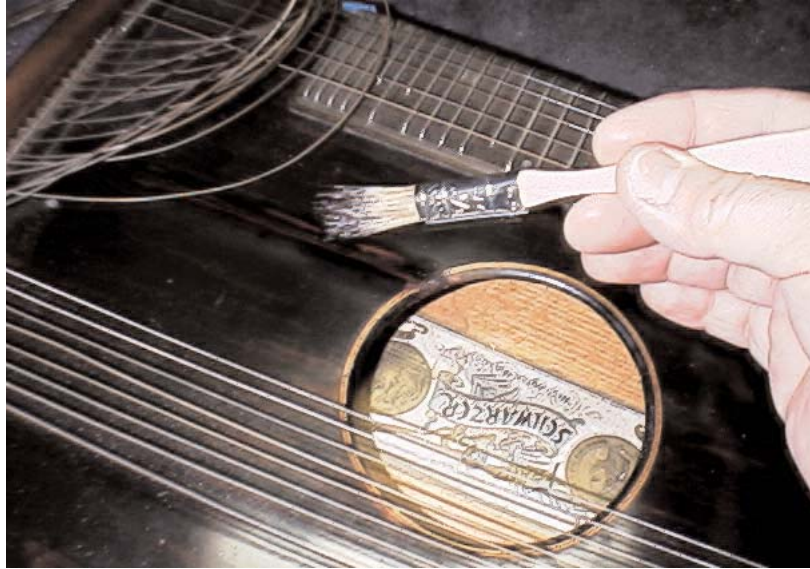
Where I repaired the top crack, I had to scrape a little of the finish to even out the joint and remove glue squeeze-out, like I did on the side joint. The finish on this instrument is what's called a faux rosewood finish. The wood is a soft wood, more than likely spruce, with dark lines painted on under a reddish-brown varnish to simulate rosewood. This type of simulation, making cheaper wood look like expensive figured wood, has been a common practice with furniture builders for hundreds of years, and it's still being done.

To duplicate that look, I started by brushing several coats of black water-based stain on the crack and the side joint. After each coat dried, I rubbed the area with 0000 steel wool, then reapplied another coat.
